**ASBESTOS - CONTAINING
BUILDING MATERIALS
INSPECTION UPDATE
April 3, 1991**

**FLINTRIDGE BUILDING
FAIRFIELD, ALABAMA**

**Professional Service Industries, Inc.
Project Number 666-19214**

**UPDATE OF SURVEY FOR ASBESTOS-CONTAINING BUILDING MATERIALS
FLINTRIDGE BUILDING
FAIRFIELD, ALABAMA**

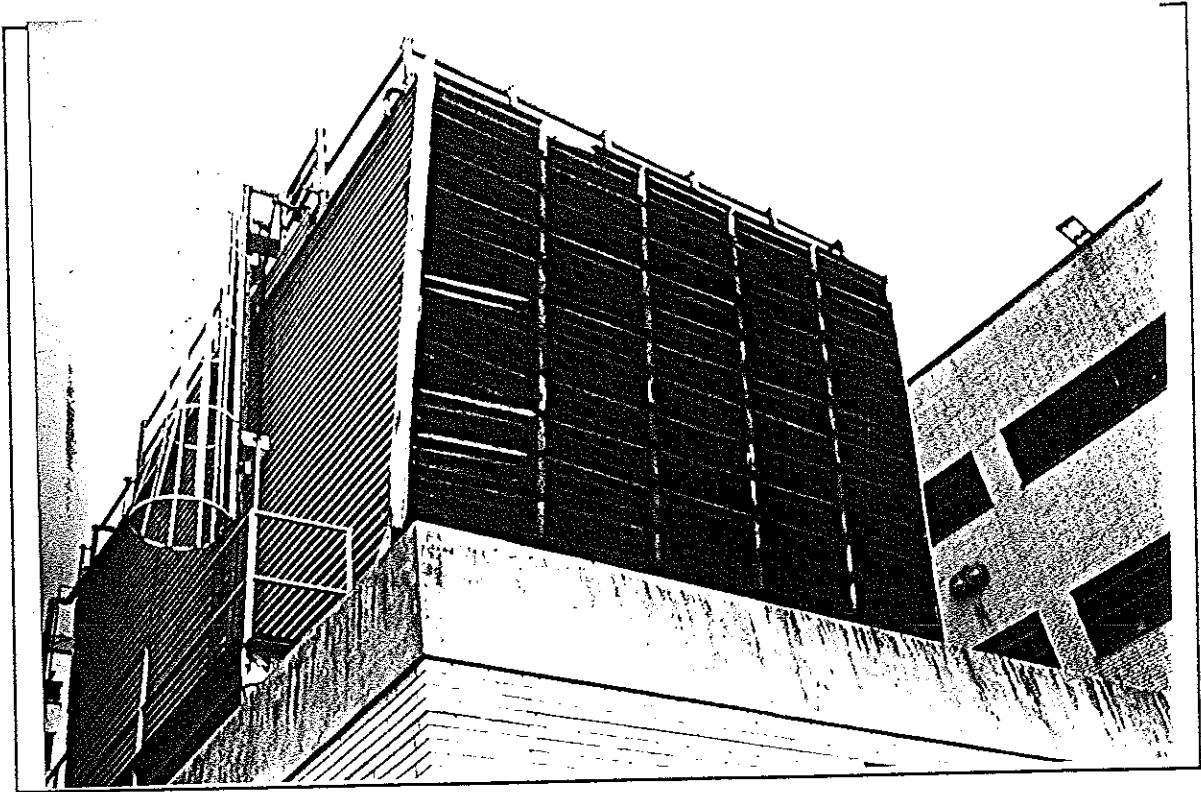
PHOTO NUMBER 18

Localized damage to friable ACBM was noted within the subject building during our October 17, 1988 survey. During our march 21, 1991 survey two areas where localized damage to friable asbestos-containing pipe insulation was found during the March 21 survey. These were pipe insulation in one of the first floor air handler rooms and pipe insulation in the crawl space (See photographs 20 and 21, Appendix A). The condition of the existing nonfriable ACBM appeared to be unchanged i.e., most of the 9 X 9 and 12 X 12 inch floor tile appeared to be in good condition except for the floor tile in an the old photographic lab on the first floor which was and is loose and broken in several places. Another exception is the cement asbestos boards on the Cooling Tower (See photograph 18, Appendix A). This material appeared to be in a more deteriorated

state with several areas of localized damage present.
