ASBESTOS SURVEY REPORT
2510 CRESTWOOD BLVD
IRONDALE, ALABAMA
BUILDING & EARTH PROJECT No.: BH190118

Subject: Asbestos Survey for
2510 Crestwood Blvd
Irondale, AL 35210
Building & Earth Project No: BH190118

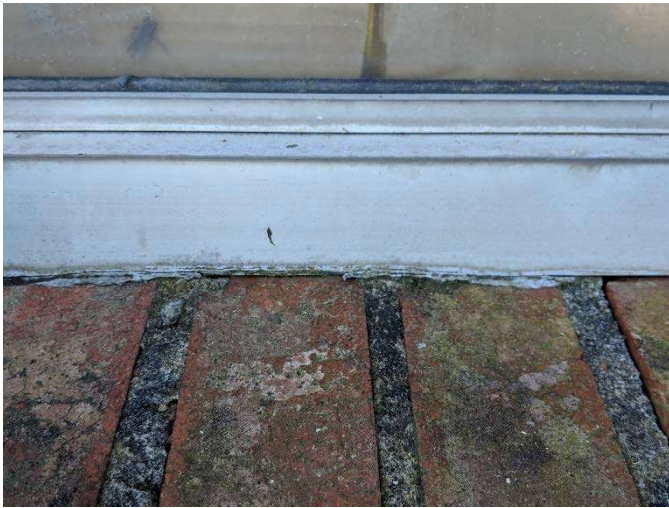
Photo #3
View of **asbestos-containing** gray caulk on metal windows & brick on exterior windows of office building

The asbestos-containing joint compound on non-asbestos containing drywall on ceilings and walls in office building and rooms 151-160 & 251-260; and gray caulking on exterior window frames on office building are considered NESHAP Category II non-friable. Since renovation or demolition activities will disturb these materials, the materials must be removed by a State of Alabama-licensed asbestos abatement contractor prior to the disturbance.

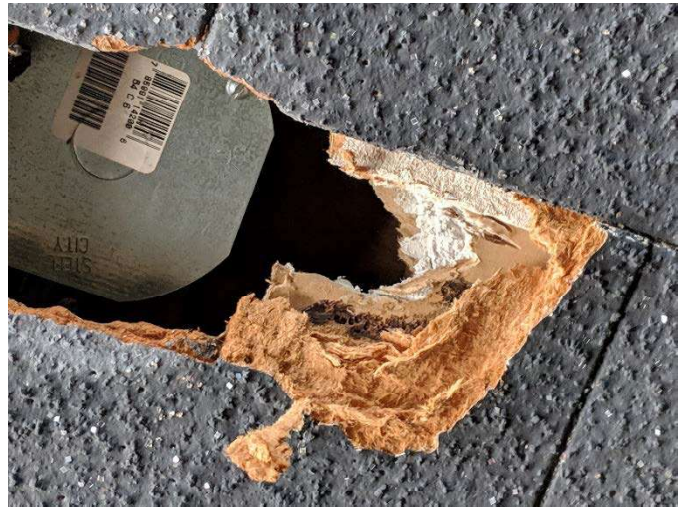
Photo #4
View of **asbestos-containing** texture and joint compound on non-asbestos drywall above non-asbestos 1'x1' ceiling tile

The asbestos-containing ceiling texture in the office building, rooms 164-168 & 225-229, rooms 101-120 & 201-220, and rooms 151-160 & 251-260 is considered RACM (regulated asbestos-containing material). This material must be removed by a State of Alabama-licensed asbestos abatement contractor prior to the disturbance.

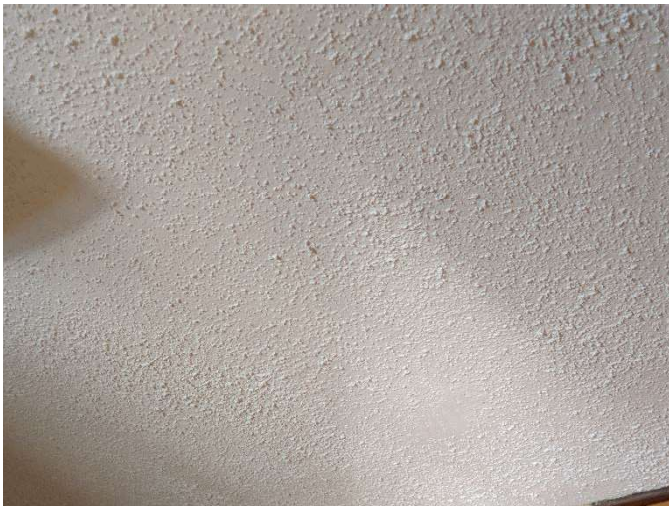
Photo #5
View of **asbestos-containing** ceiling texture in office building

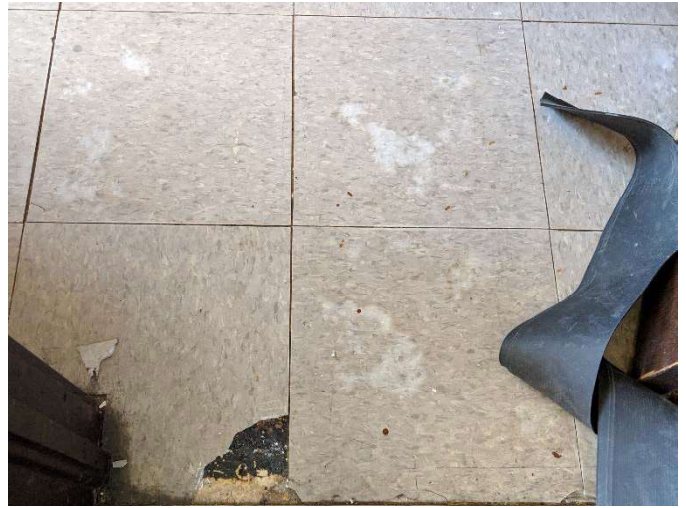
Photo #2
View of **asbestos-containing** black mastic on
non-asbestos 12"x12" vinyl floor tile

The asbestos-containing black mastic on non-asbestos 12"x12" vinyl floor tile in room 147 and black/brown mastic on non-asbestos containing vinyl sheet flooring in kitchen areas in rooms 151-160 & 251-260 are considered NESHAP Category I non-friable. Since renovation or demolition activities will disturb these materials, Building and Earth

recommends the materials be removed by a State of Alabama-licensed asbestos abatement contractor prior to the disturbance.

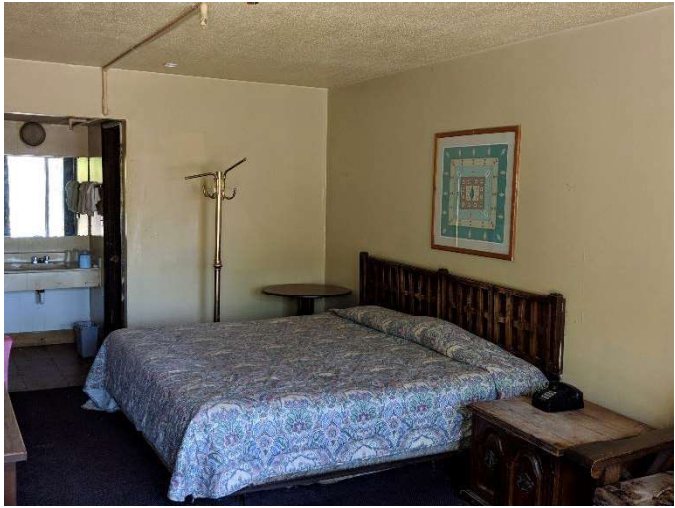
Photo #2
View of **asbestos-containing** ceiling texture in
rooms 164-168 & 225-229

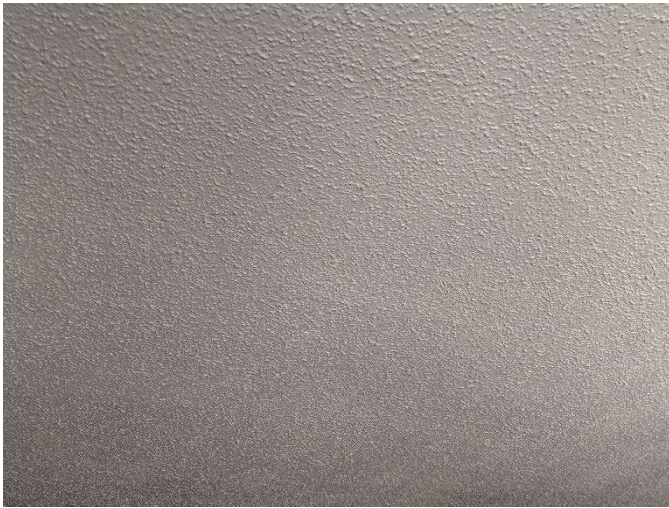
Photo #3
View of **asbestos-containing** ceiling texture in
rooms 101-120 & 201-220

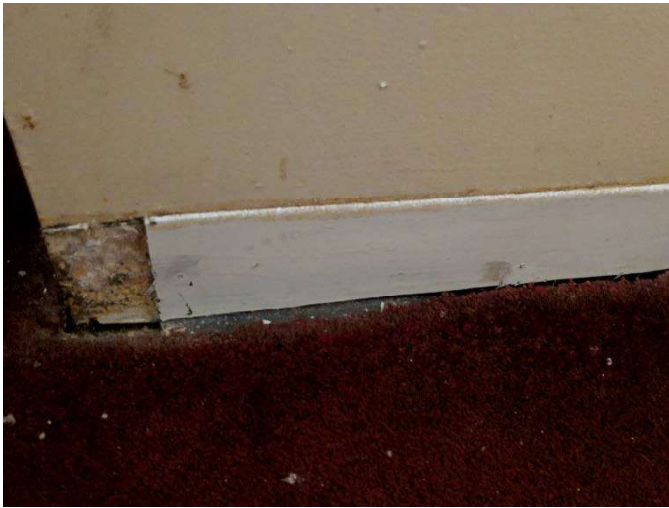
Photo 3
View of **asbestos-containing** joint compound on non-asbestos drywall in rooms 151-160 & 251-260

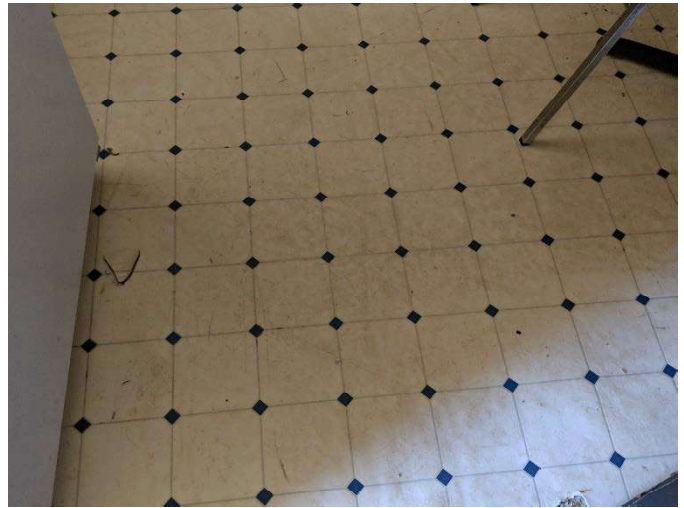
Photo 4
View of **asbestos-containing** brown/black mastic on non-asbestos vinyl sheet flooring in rooms 151-160 & 251-260

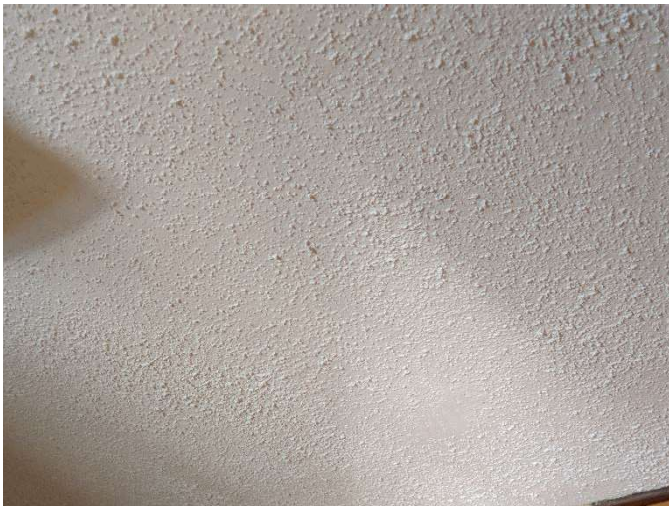
Photo 5
View of **asbestos-containing** ceiling texture in rooms 151-160 & 251-260
